# The use of COMSOL for Building Constructions Engineering regarding Heat and Moisture Transport

H.L. (Henk) Schellen, A. W. M. (Jos) van Schijndel\* & P. M. (Petra) Briggen  
Eindhoven University of Technology

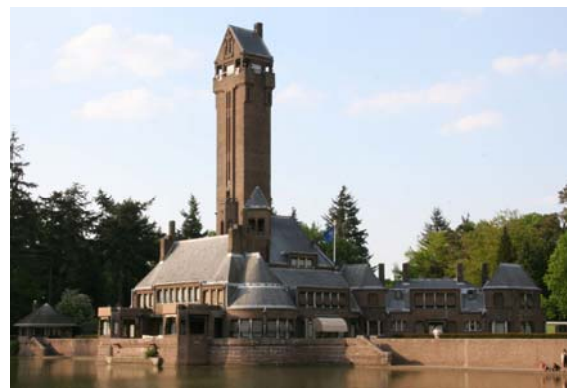
**Figure 1.** Hunting Lodge St. Hubertus.

Hunting Lodge St. Hubertus is situated in the midst of the extensive natural reserves of the Dutch National Park De Hoge Veluwe (Figure 1). The Hunting Lodge was built between 1916 and 1922 by Holland's most well-known architect from that time: H.P. Berlage. It is one of the most prominent buildings from the beginning of the twentieth century and is noted in the top 100 list of Dutch monuments. The floor plan of the brick structure is characterized by the tower in the middle of the building with a height of over 30 meters and by the wings that stretch out diagonally. Hunting Lodge St. Hubertus is part of the Dutch cultural heritage and is state property.

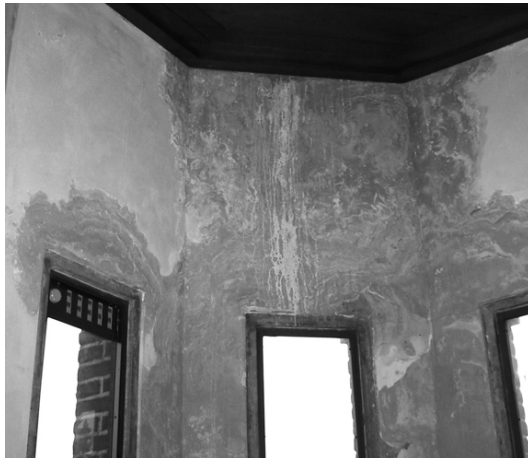
**Figure 2.** Moisture damage at the inside of the tower

The damage on the inside of the tower, and where possible also on the outside, is systematically inspected. The location and type of each moisture problem are documented in a table, illustrated with a picture of the damage. The moisture problems that manifest themselves in the tower of the Hunting Lodge can be divided in the following categories: efflorescence, cracking, soiling, moist spots, mechanical damage and biological growth. A picture of the typical moisture damage that occurs in the tower is shown in Figure 2.

Regarding the location of the damage it can be concluded from the inspection that most damage occurs on the interior surface of the south-west facade of the tower. Since the prevailing wind direction in the Netherlands is south-west, which means that the south-west facade of the tower is subjected to wind-driven rain the most, there appears to be a connection between the rain load of the facade and the damage on the inside. There are no clear differences between the damage on lower or higher floors or between the

damage on the middle and on the sides of the facade. Most damage occurs near openings in the facade and on the interior surface of the facade below balconies.

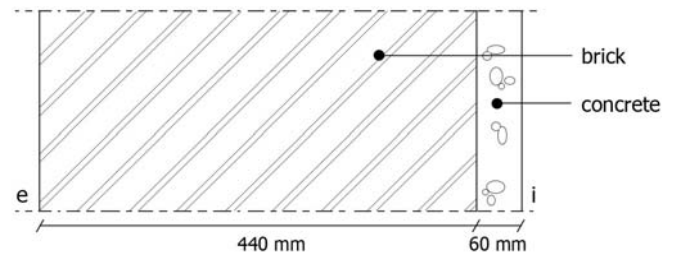
**Figure 3.** Horizontal section of the building facade

The data set is part of the measurement program at the Hunting Lodge St. Hubertus site, performed during 2006-2007 by Briggen (2007). Details of this project can be found there. One of problems seemed to be high moisture contents at the inside surface of the facade of the tower. The construction of this facade is shown in figure 3.

This paper comprehends the heat and moisture transport inside the walls of the tower. Figure 3 shows a cross-section of these walls, consisting of two materials: brick and concrete.

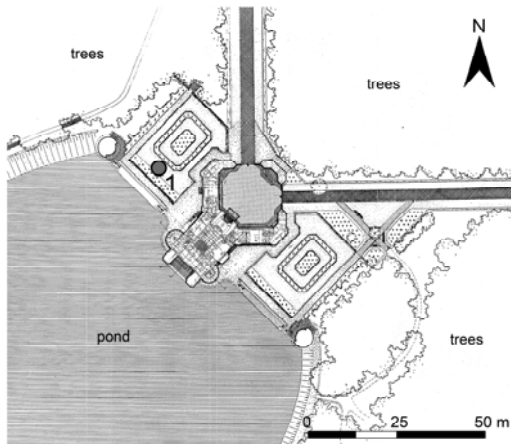
**Figure 4.** Position of the meteorological mast (measurement of reference wind speed and reference wind direction) and the horizontal rain gauge, position 1.

The outside climate conditions were measured by a weather station within 50m from the building. See figure 4.

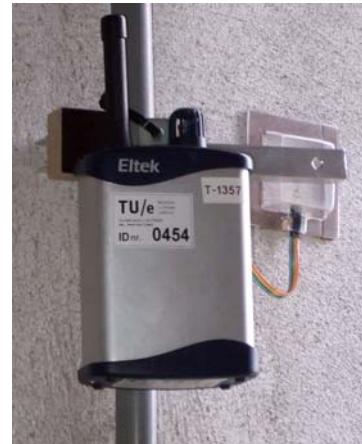
**Figure 6.** Measurement of the surface temperature and relative humidity at the inside surface of the tower, using a closed box, connected to the inside surface, supposed to be in equilibrium with the wall.

The inside air temperature and relative humidity were measured using standard equipment (see figure 6). A representation of inside surface conditions was obtained by placing a small box (5cm x 5cm x 1cm) against the wall and measure the air temperature and relative humidity inside. The estimation of the measurement error of this method is left over for future research.

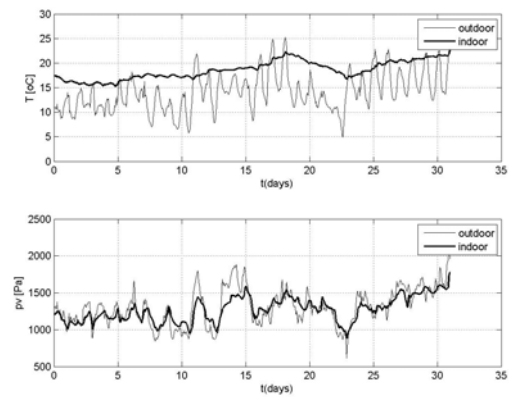
**Figure 7.** The measured air temperatures (top) and calculated vapour pressures (bottom, from measured T/RH)

The *input* data consist of the measured time series of the indoor and outdoor climate as presented in figures 7 and 8.

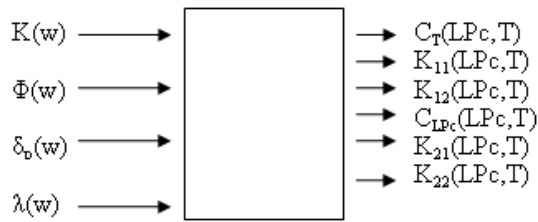
**Figure 9.** The conversion from measurable material properties into PDE coefficients

The second extension is the implementation of advanced material and boundary functions using Matlab. These functions are used to convert measurable material properties such as K, φ, δ<sub>p</sub> and λ which are dependent on the moisture content into PDE coefficients which are dependent on

the LPc and T. This is schematically shown in figure 9.

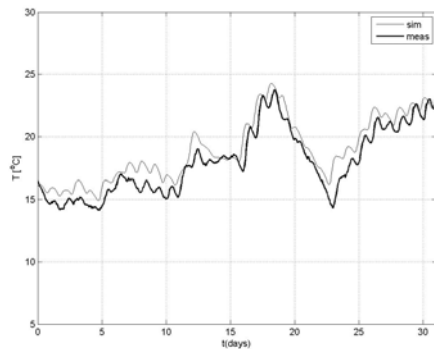
**Figure 10.** The measured and simulated inside surface temperature.

Figure 10 shows that the simulated inside surface temperature is already quite close to the measured one.

The material database of DELPHIN (2008) is used to provide material properties. For brick, the Brick material properties of DELPHIN are used with constant  $\rho = 1700$ ;  $c = 840$ ;  $\lambda = 0.85$  and variable moisture properties using the tables. For concrete, the Lime plaster properties of DELPHIN ( $\rho = 1800$ ;  $c = 840$ ;  $\lambda = 1.05$ ) are used in the same way. From these data, the PDE coefficients were determined similar to figure 9 and together with the boundary conditions implemented using the COMSOL model of Section 5. Figure 10 and 11 show the results.

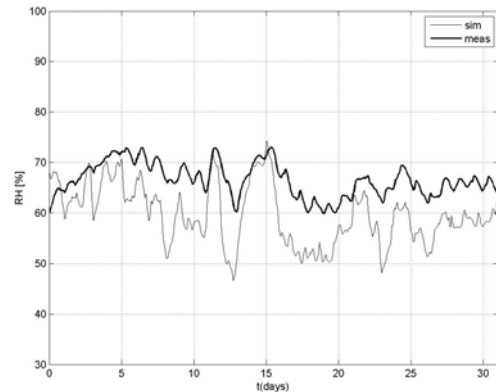
**Figure 11.** The measured and simulated relative humidity at the surface.

The simulated relative humidity at the inside surface of figure 11 seems to be less close to the measured one compared to the previous figure.
