Heat and moisture in wooden bearings of monumental buildings

Henk Schellen TU/e
Jos van Schijndel TU/e
Menno Spierenburg DPA

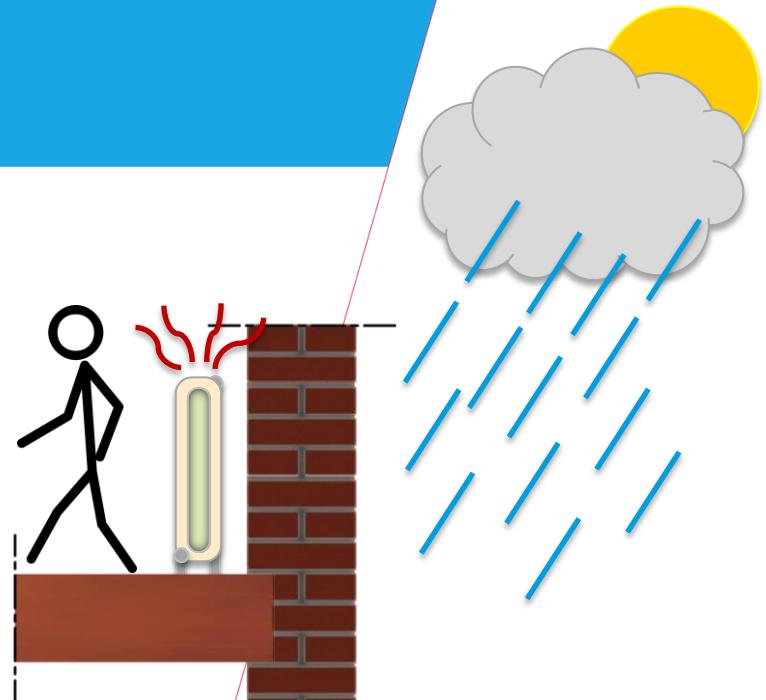
Risks typical construction

- High wind driven rain load
- Leakages
- Cracks
